47<sup>TH</sup> TURBOMACHINERY & 34<sup>TH</sup> PUMP SYMPOSIA  
HOUSTON, TEXAS | SEPTEMBER 17-20, 2018  
GEORGE R. BROWN CONVENTION CENTER

## Dry Gas Seal Failure due to Axial Sub-synchronous Vibration on a Hydrogen Recycle Gas Compressor.

Robert C. Eisenmann, Jr. - BP Machinery Advisor  
Luis Santos-Gutierrez – Rotating Equipment  
Engineering Superintendent

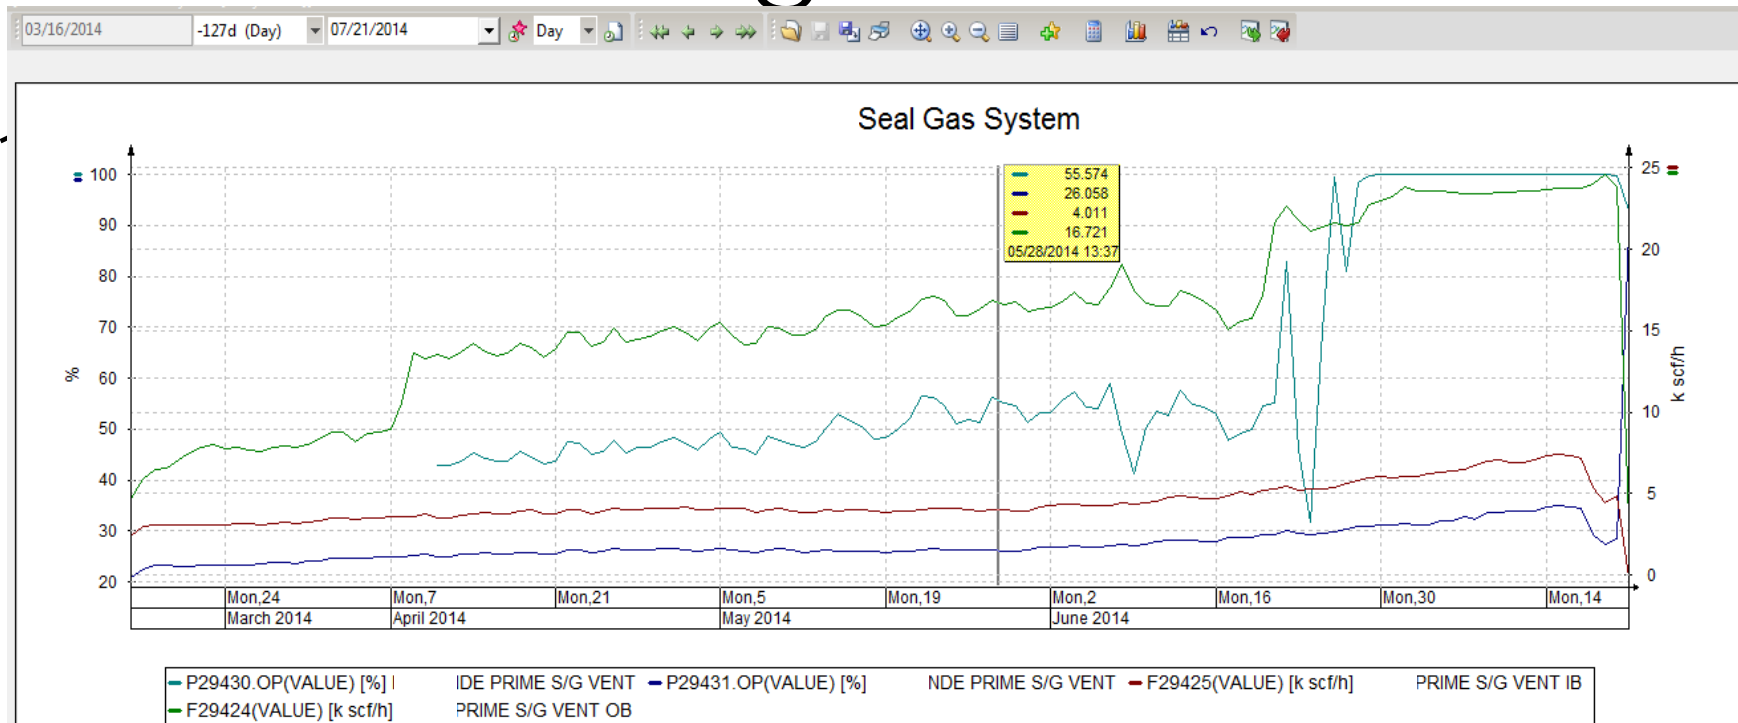
# Increasing Vent Flow

- Initial failure was detected 4 months after initial commissioning.
- Vent flow and control valve position changed over time indicating a degrading seal.
- Outage occurred in July of 2014 (~6 months of operation).
- Seals were replaced, failure investigated.

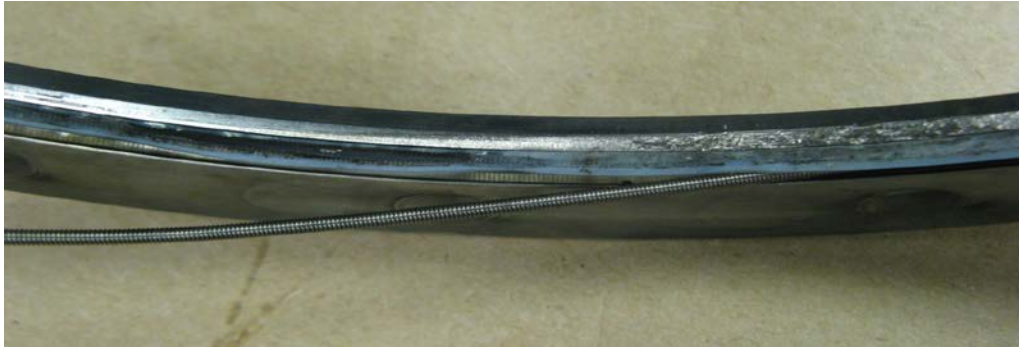
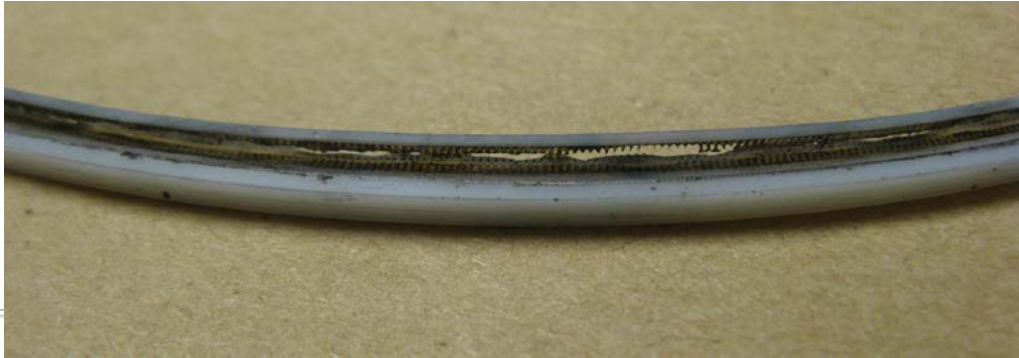
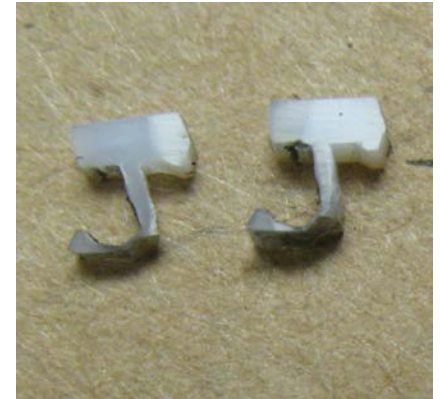
# Failed "J" Ring and spring holder

- PTFE J-ring failed due to fretting and accelerated by:
  - Contamination/debris
    - Amplifier did not function during a previous unit shutdown
  - Swash (axial movement)
    - Indication of incorrect contact on nut assembly

- Perform lapping and contact checks on the seal sleeve to locking nut to ensure perpendicularity and avoid potential for “swash”
  - Bluing showed 85-90% contact
- Perform run-out check on thrust collar to ensure that no axial run-out
  - Run-out found to be  $<0.0005$ ”
- Seal gas booster was replaced
  - PM established to test functionality of seal gas booster

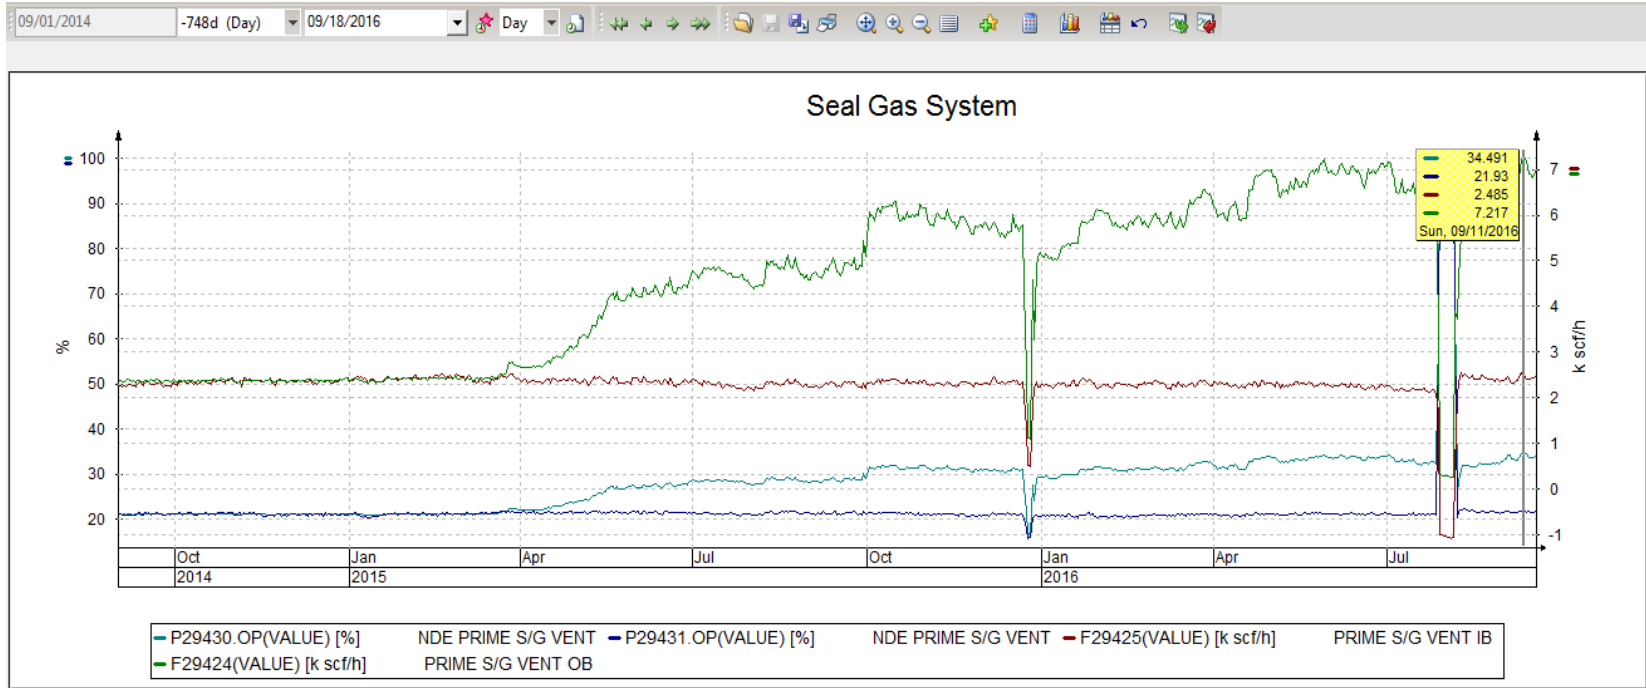
# Primary seal vent trends for 2<sup>nd</sup> run

- Machine ran for 7 months with no issue.
- At 7 months noticed that vent flows and control valve position of outboard seals started changing indicating a degrading seal.
- RCA was re-initiated.
- Outage occurred in Fall of 2016 (~27 months of operation) to implement solution and address degrading seal.
- Same failure mode as first failure

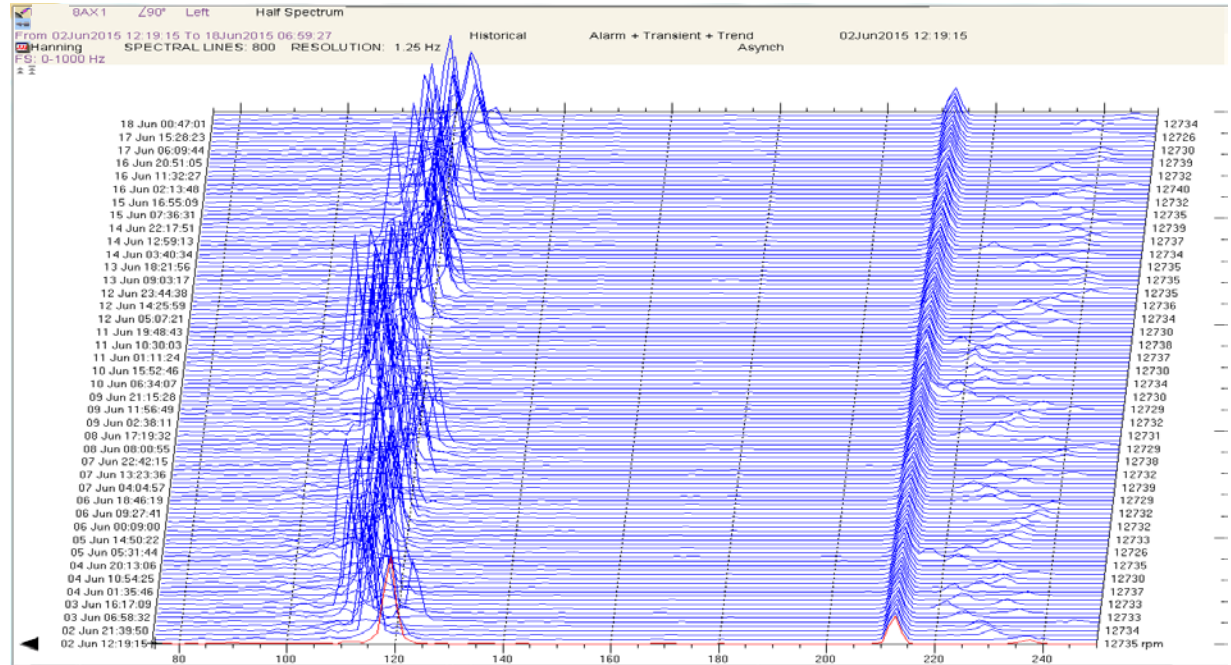
- June 2015 axial probes were configured to collect vibration
- Discovered sub-synchronous axial vibration around half running speed (110Hz-125Hz ) with peaks up to 2.5 mils (0.0635 mm/sec)
- This finding shows that axial shuttling is happening under normal operation causing accelerated wear on PTFE J ring.

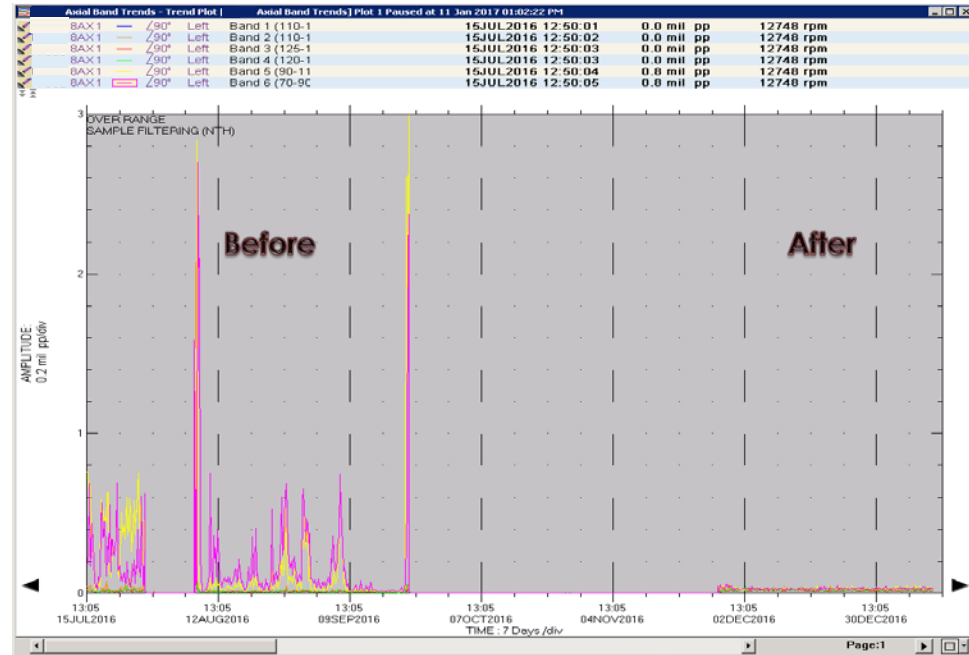
# Defect Elimination: H2 Recycle Compressor @GOHT

- Installed new pre-loaded thrust bearing in 2016 (Bearing with o-ring dampner)
- Axial vibration was reduced over 75% during normal operation.
- After 1 year of operation axial vibration has not increased from startup condition.
